**THE CALIFORNIA EARTHQUAKE OF APRIL 18, 1906**

**REPORT**

**OF THE**

ANDREW C. LAWSON

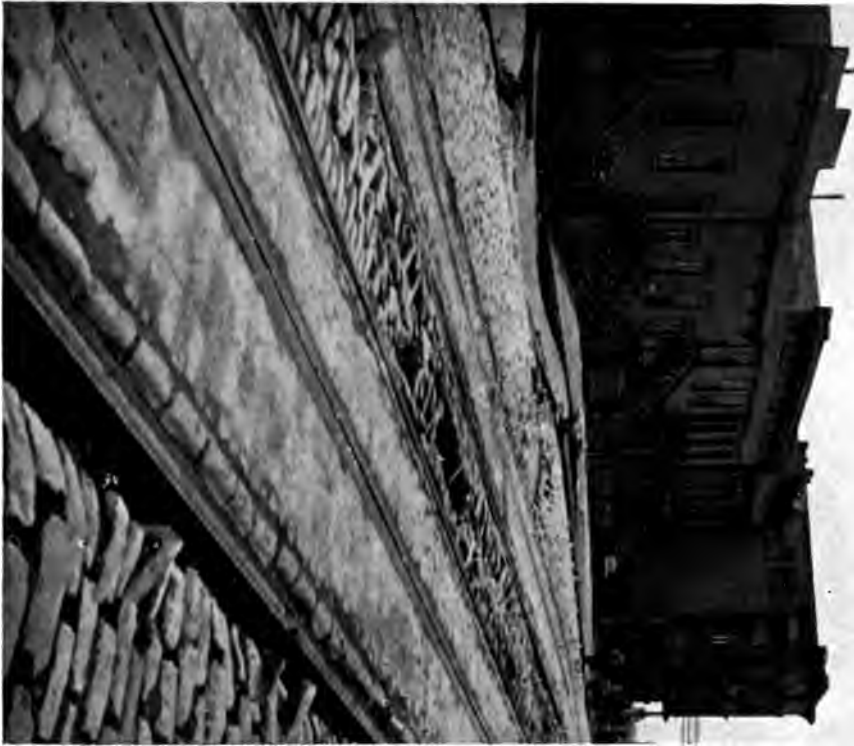
**A. Ninth Street, between Bryant and Brennan. Undulation and flaring of pavement and sidewalks. Houses over trough have been dropped from their underpinning. G. K. G.**

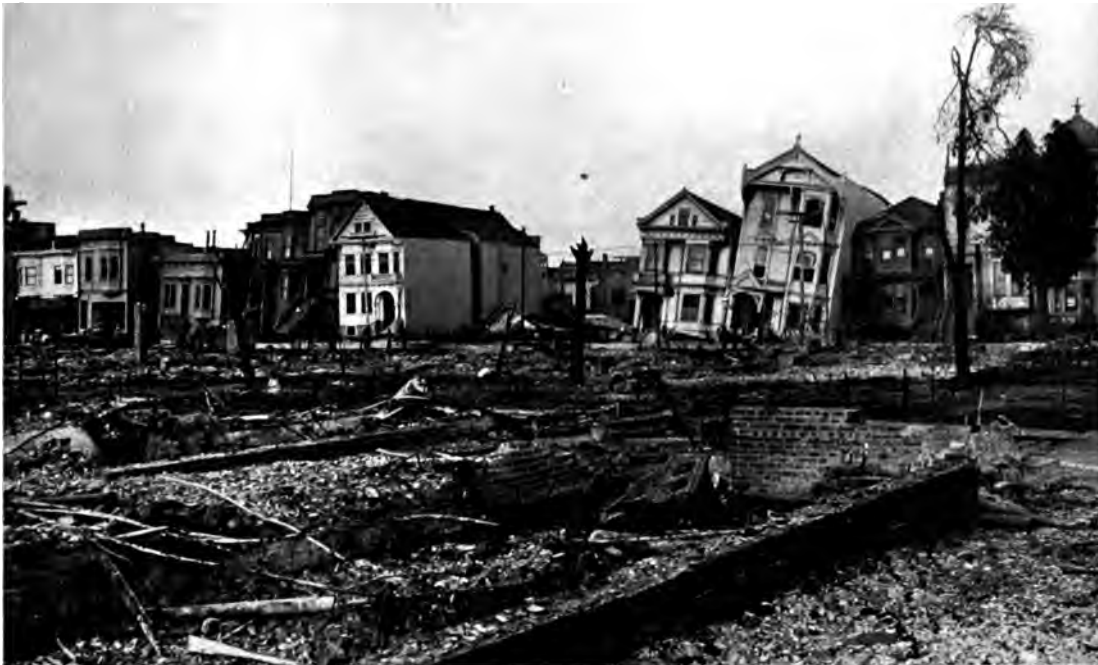
A. East side of Howard Street, between Seventeenth and Eighteenth Streets. A. C. L.

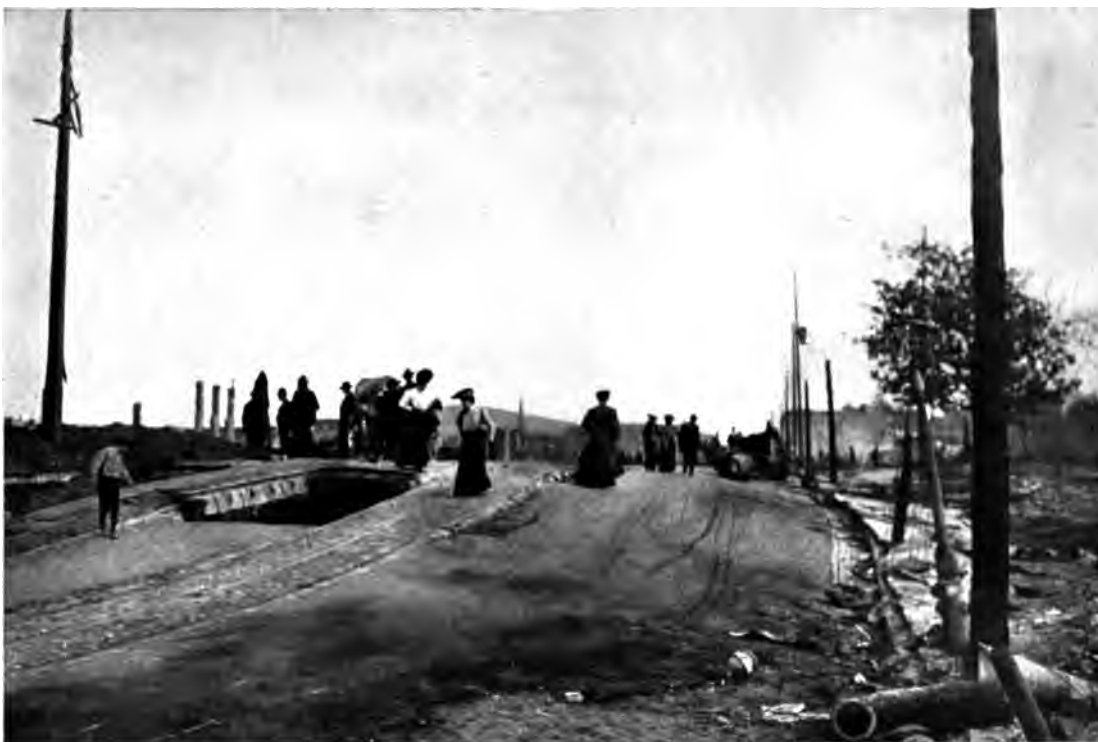
B. Valencia Street, near Eighteenth. Land in this neighborhood sank about 6 feet, flexing street surface. A. C. L.

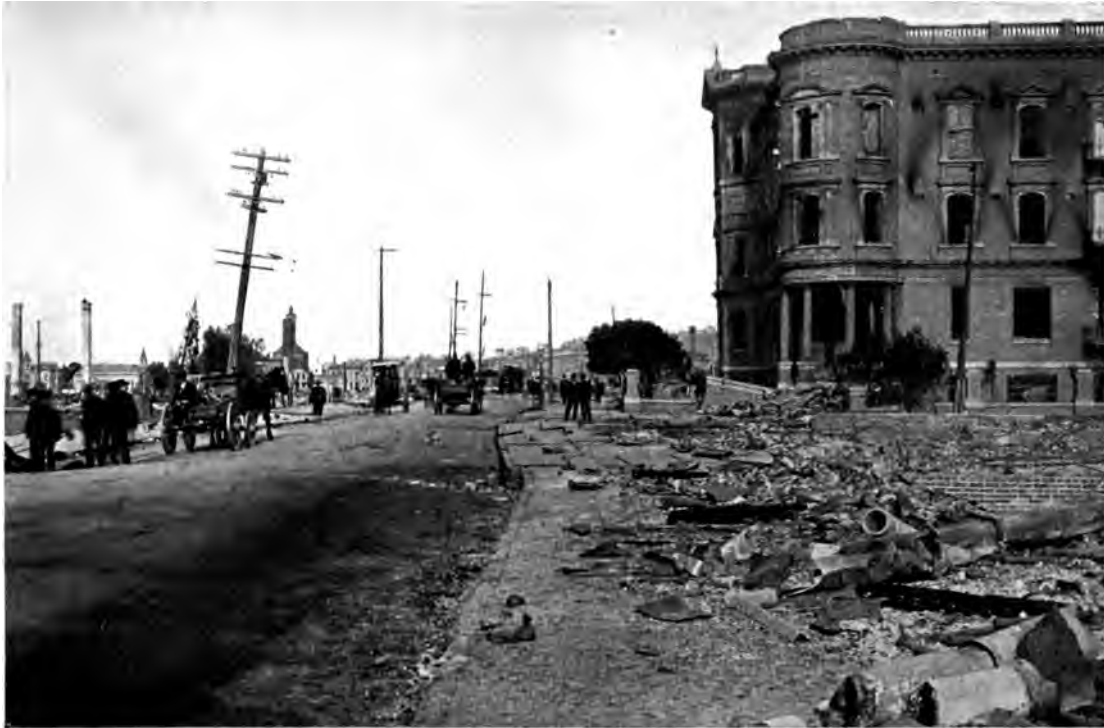
A. View along Nineteenth Street, from Guerrero Street. Both ground and buildings moved north about 6 feet toward center of old marsh, with component of movement down the channel. A. C. L.

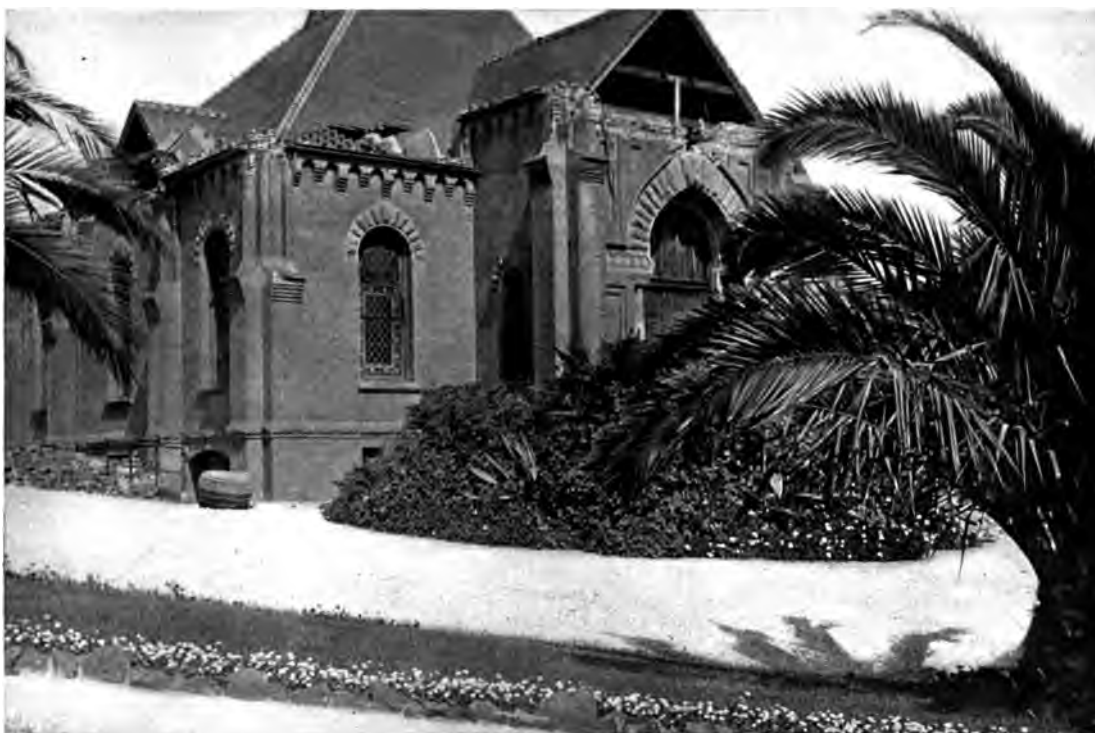
B. Hills of Eternity Cemetery, south of San Francisco. All four gables thrown out. Parapets thrown in on roof. A. C. L.

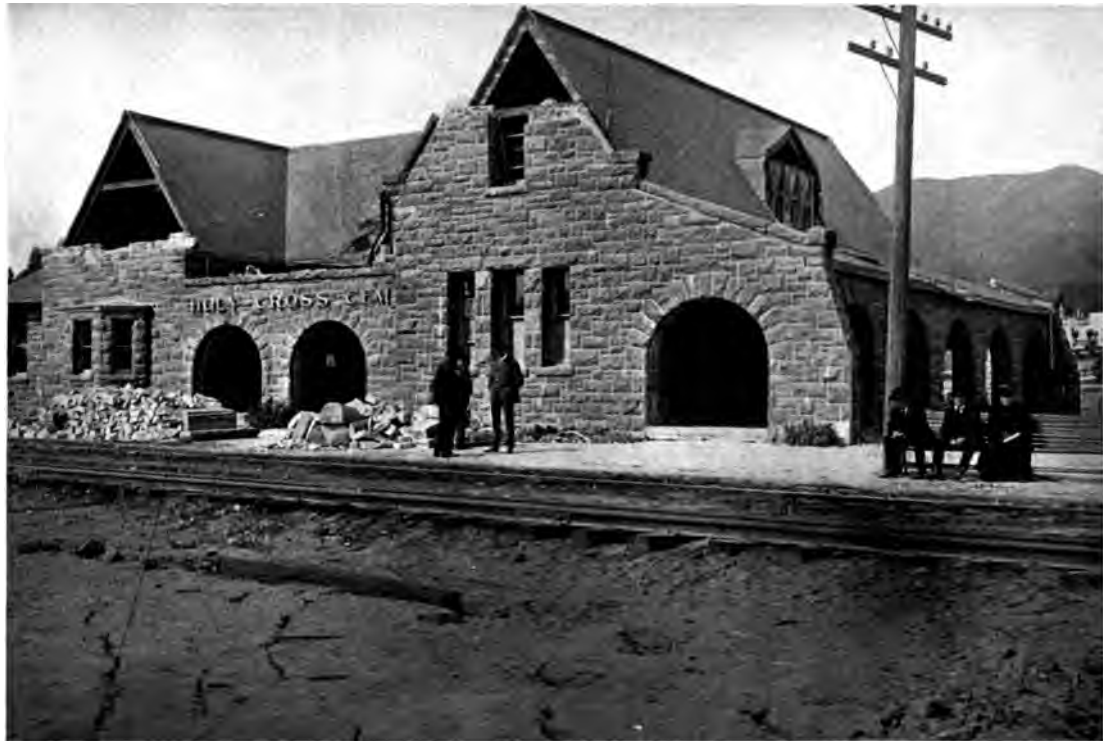
A. Holy Cross Cemetery Station, south of San Francisco. Building on made ground. A. C. L.

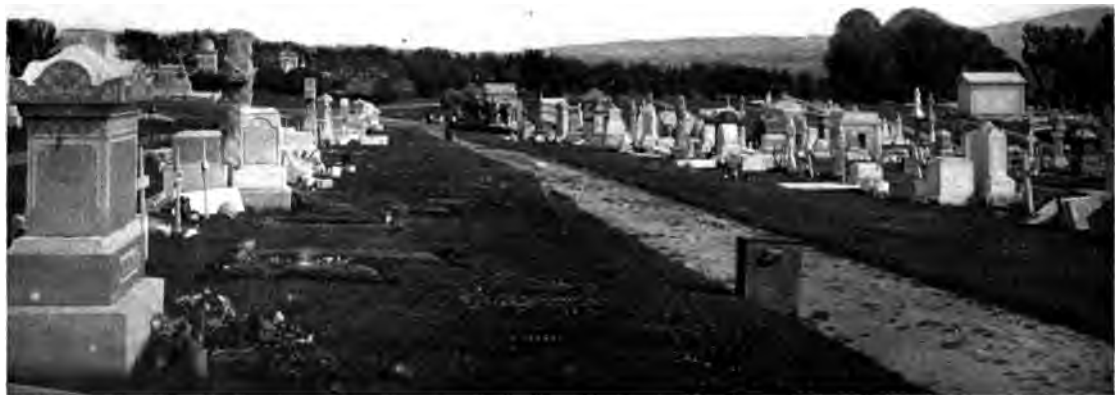
B. Holy Cross Cemetery, south of San Francisco. A. C. L.

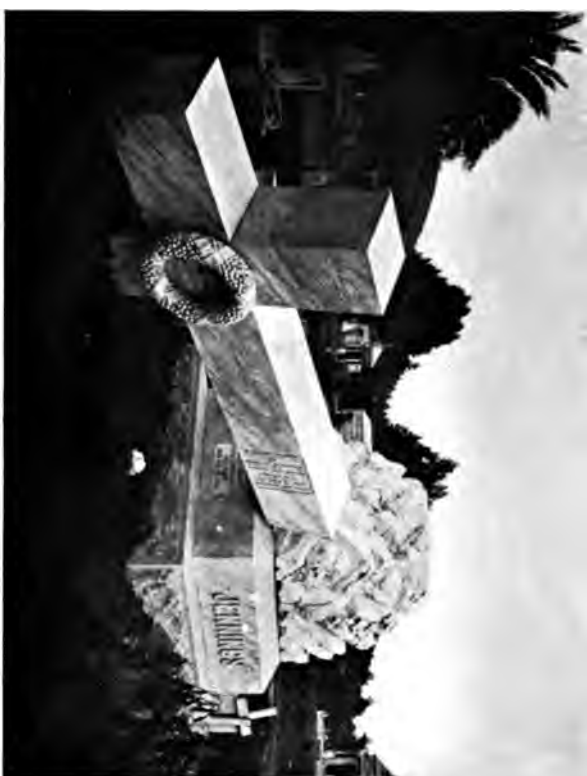
A. Overthrown monument, Holy Cross Cemetery, R. B. M.

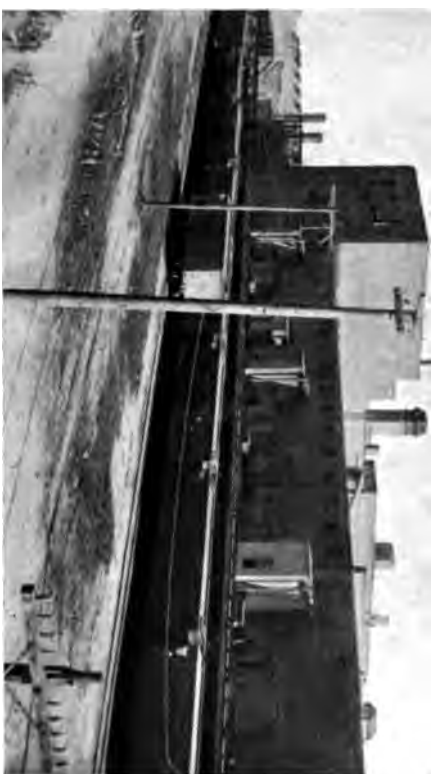
B. Brick building and high chimney left standing, South San Francisco, R. B. M.

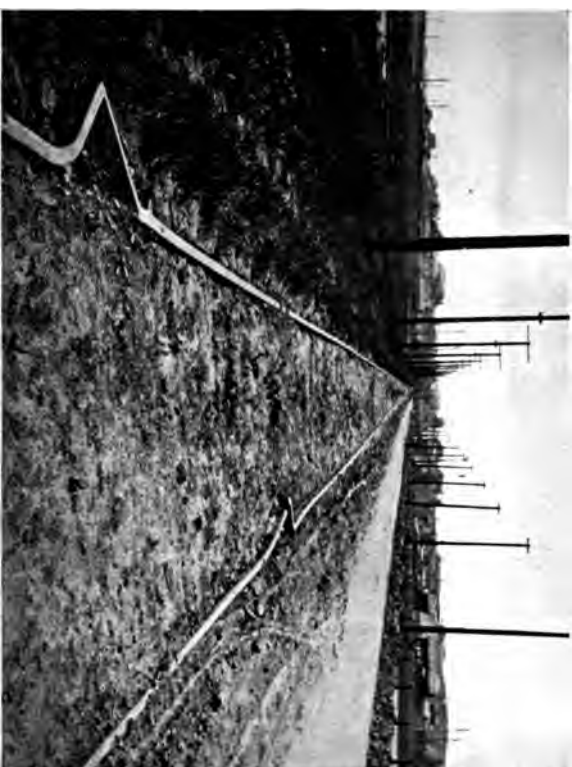
C. Roadbed and rails of electric railway on marsh west of San Bruno, R. B. M.

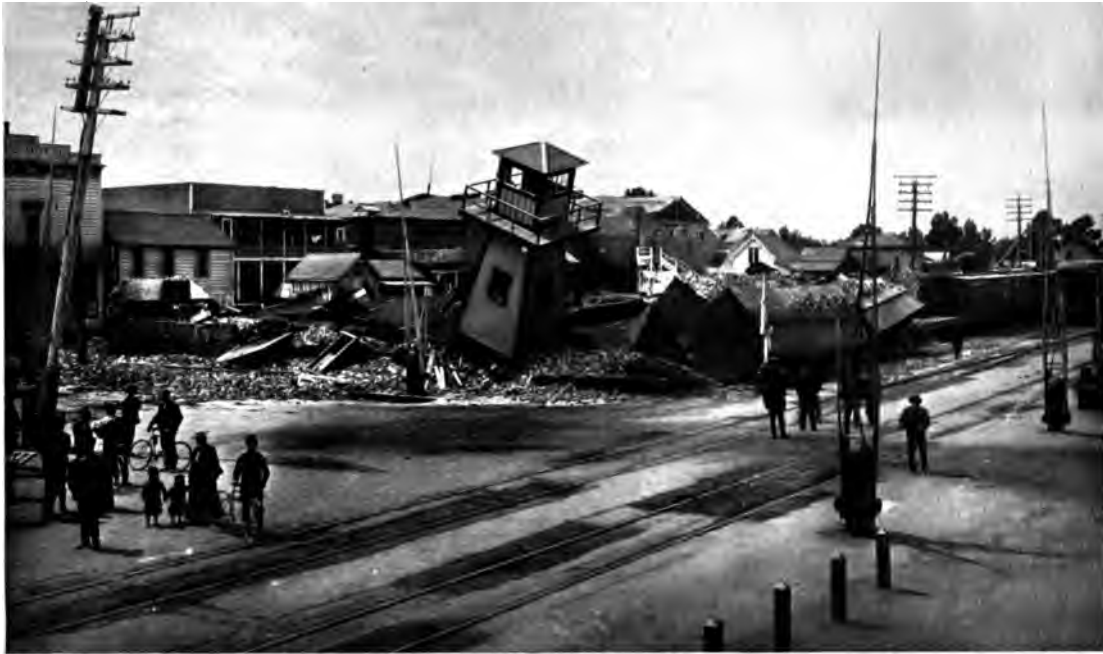
A. Wreck of 1-story brick railway warehouse, San Mateo. Per J. O. B.
